# X-33 LH<sub>2</sub> Tank Failure Investigation Findings

*Presented by*  
Mindy Niedermeyer  
MSFC

*Aerospace Materials, Processes, and Environmental  
Technology Conference*

September 18 - 20, 2000

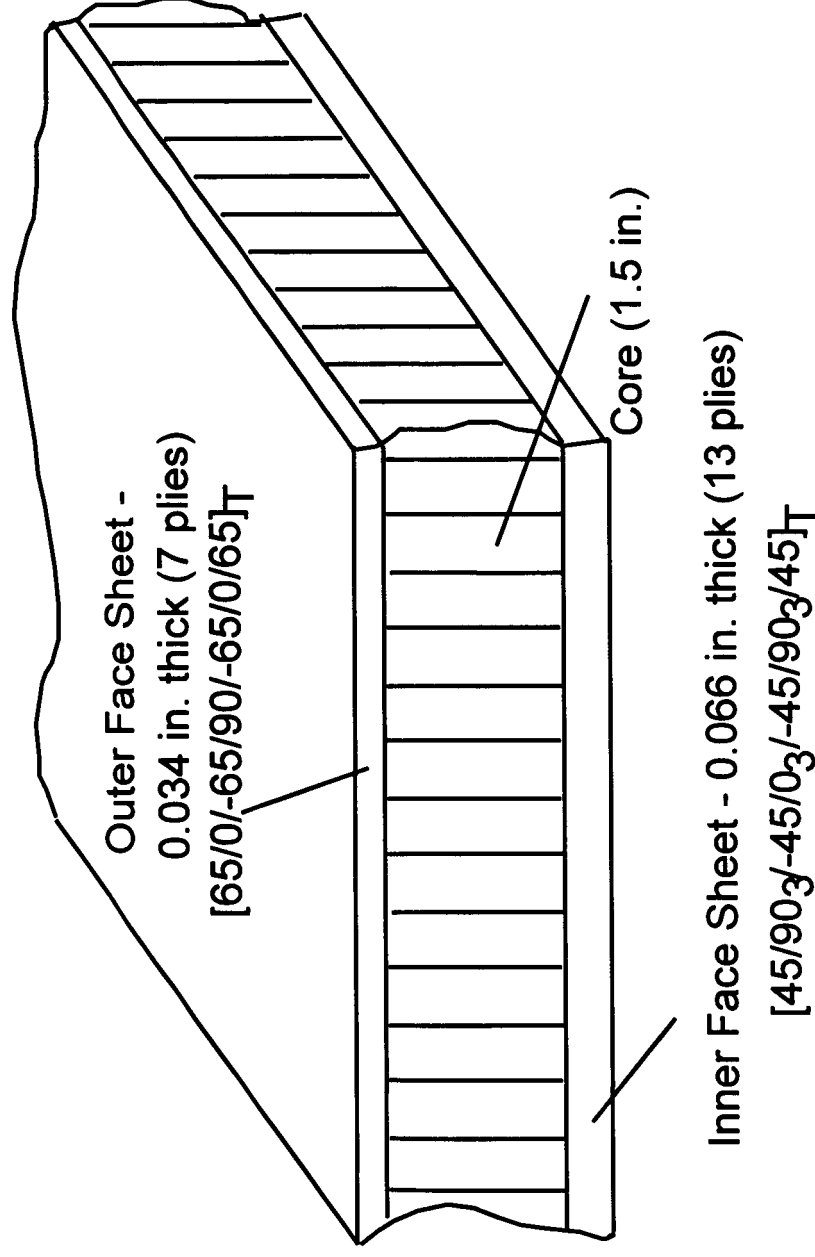
## **Geometry of sandwich structure**

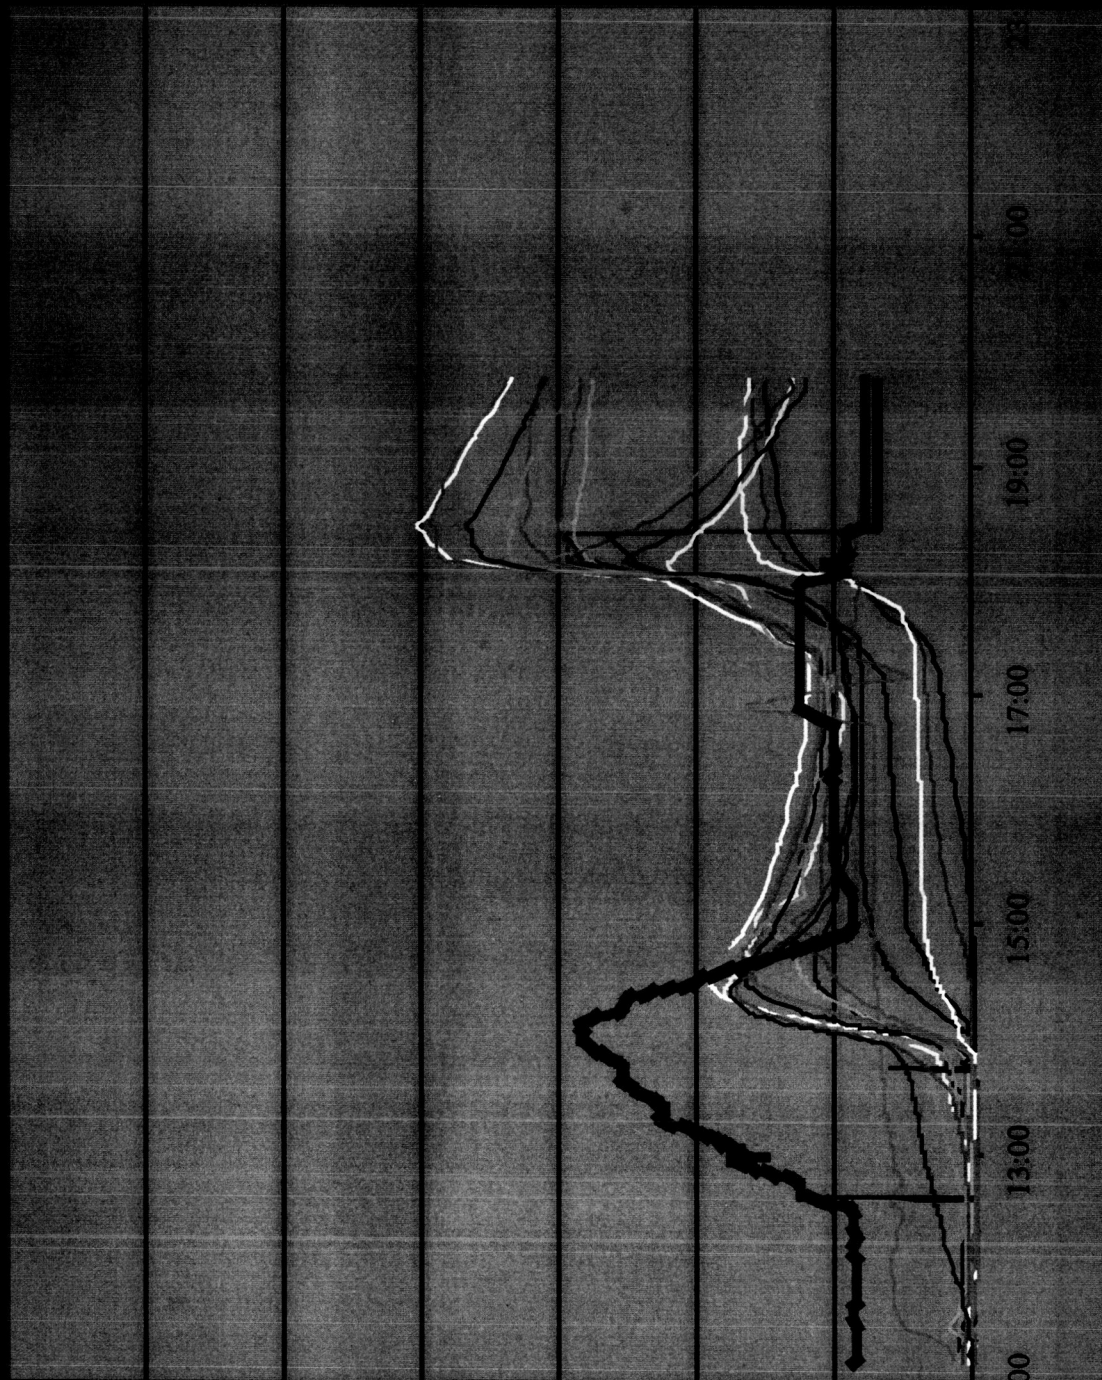
- Core pressures behaved unexpectedly
- Microcracking

# re Pressure vs T

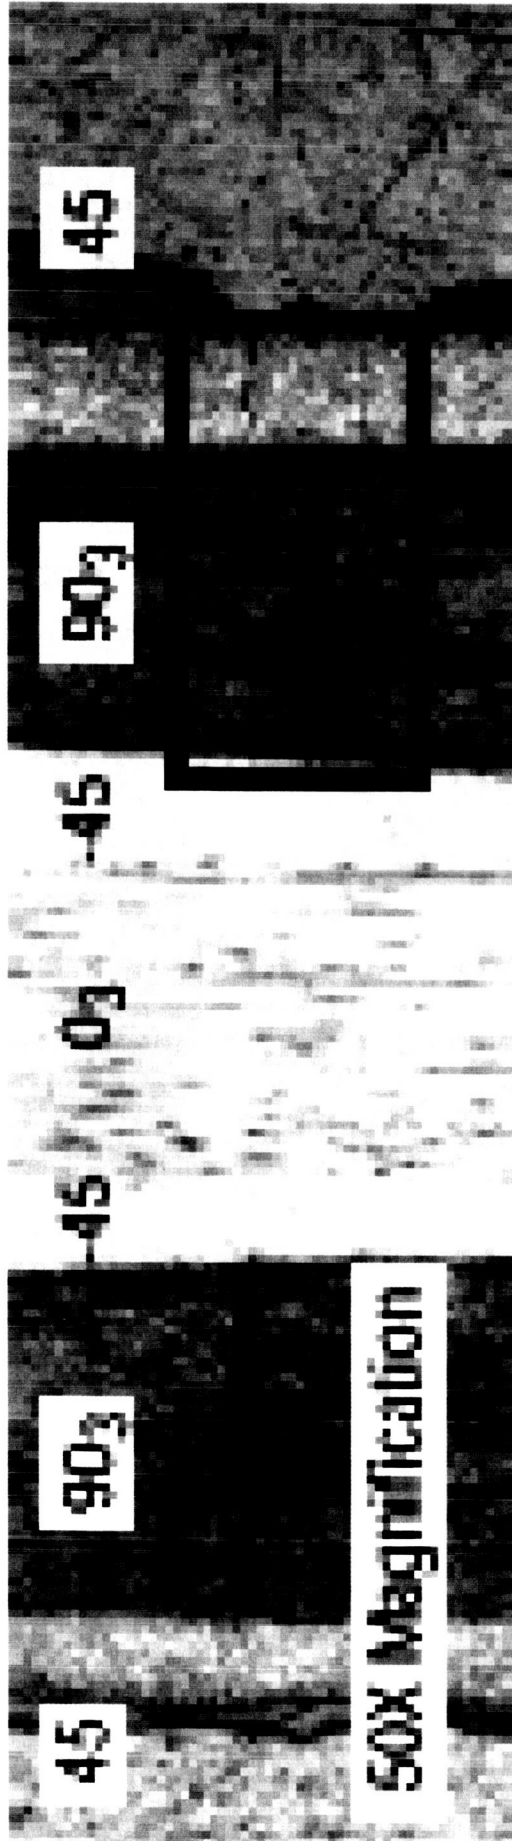
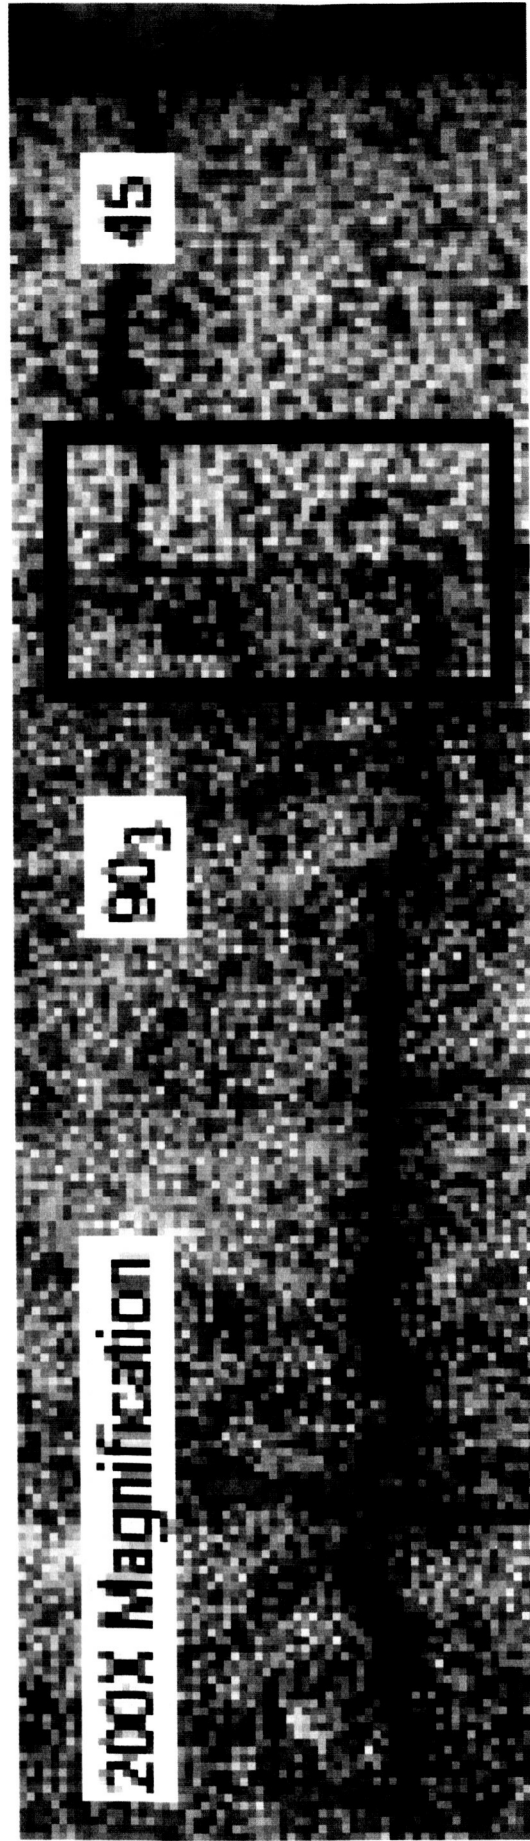
500X Magnification

- The inner skin microcracked and hydrogen infiltrated
- The cracks grew larger under pressure
- When pressure was removed cracks closed slightly
- When tank was drained and warmed, cracks closed and blocked leak path
- FOD and debond areas provided an opportunity for a leak path
- There is still hydrogen in the other 3 lobes today
